# WATER PUMP TECHNICAL SUPPORT BOOK

# What is a water pump?

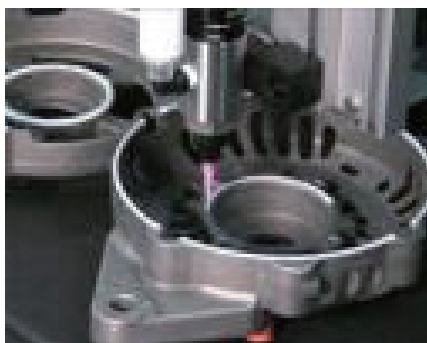
### ■ Liquid gasket applicator

In the production line, stringent control on the application amount is implemented by the use of components including an FIPG applicator.

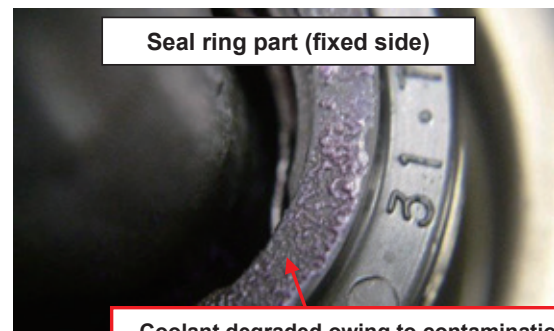
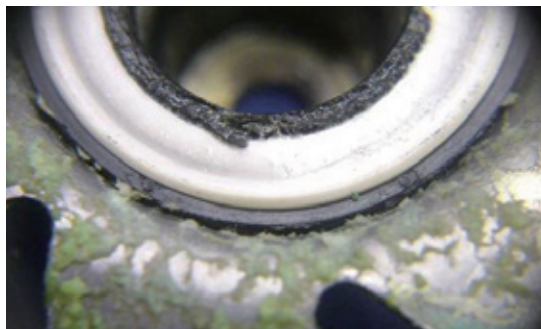
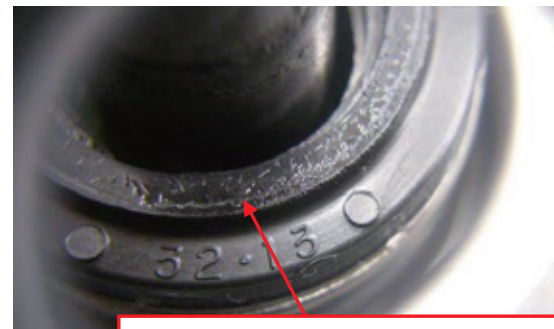
#### (1) Coolant contamination

Mating ring part (rotating side)

Seal ring part (fixed side)

Coolant degraded owing to contamination

Coolant circulates in the engine, and naturally becomes dirty as the operating time accumulates. For this reason, a periodic replacement is necessary as regular maintenance. However, when replacing the pump, it is additionally required to perform thorough cleaning and replace the entire volume of coolant with new one.

- If cleaning is not sufficient or the coolant is not replaced in its entirety, contaminants such as dust, sludge, and sand in the coolant path can be caught onto the mechanical seal sliding surface (seal surface), and coolant may leak from the drain hole resulting from a loss of sealing performance.

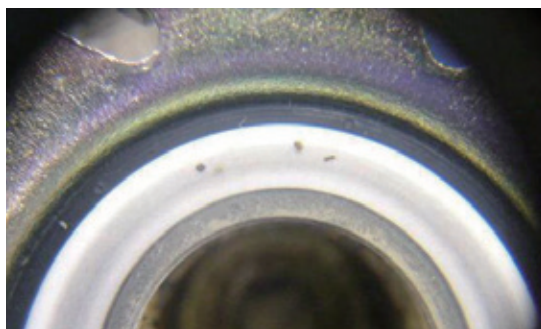
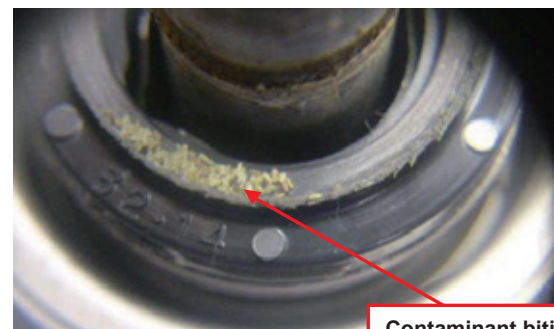
#### (2) Contaminant biting in mechanical seal

Contaminant biting

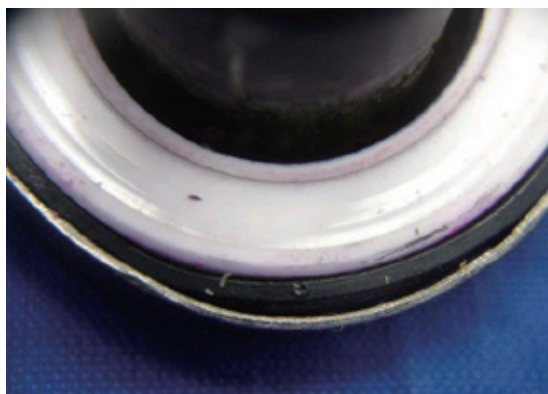
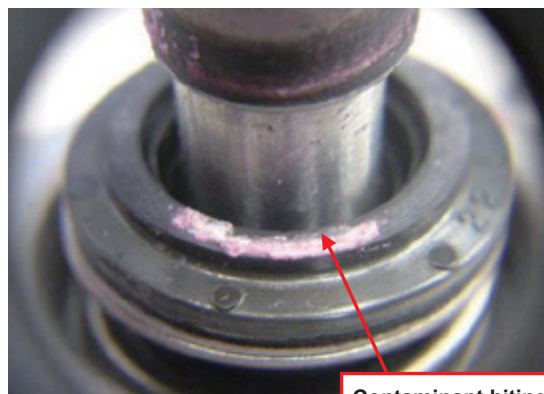
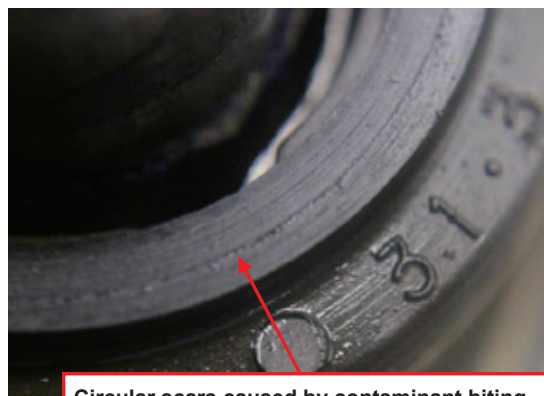
### (3) Contaminant biting in mechanical seal

Travel distance: 42 km

Travel distance: 2,352 km

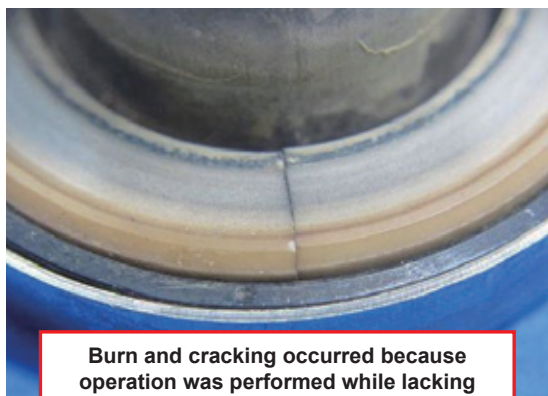
### (4) Burn and cracking of mating ring

Travel distance: 8,189 km

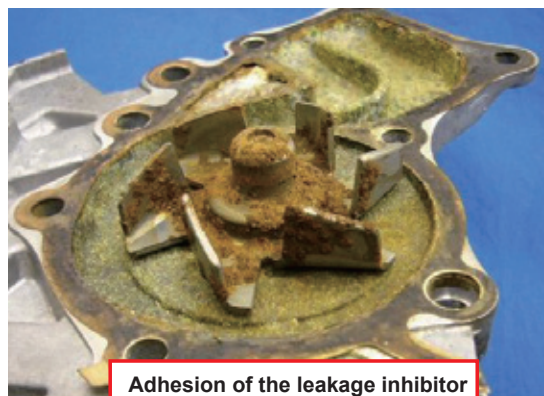
### (5) Other (charging of leakage inhibitor)

Travel distance: 10,000 km

**5 For the coolant, do not use anything other than LLC.  
(Radiator leakage inhibitor, etc.)**

- Any substance can become a contaminant in the coolant and cause issues due to consequent mechanical seal damage.

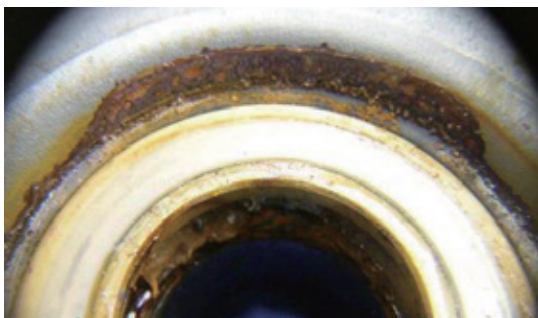
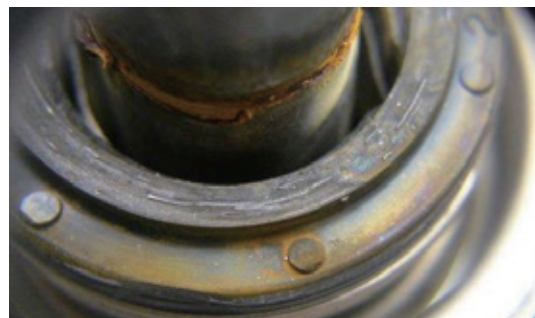
#### (1) Rust biting in mechanical seal

- Metal corrosion can generate biting contaminants, such as rust, in the mechanical seal sliding surface (seal surface), ultimately causing coolant leak from the drain hole.
- Propagation of metal corrosion and **\*cavitation** can lead to coolant leak resulting from pitting as well as to overheating resulting from a loss of impeller.

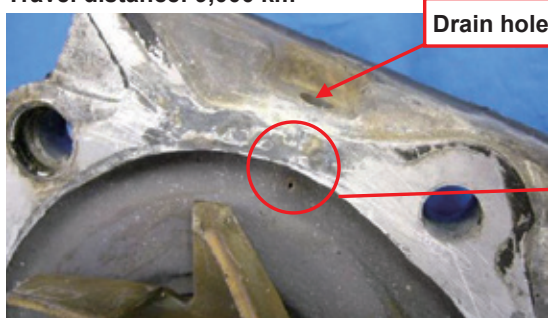
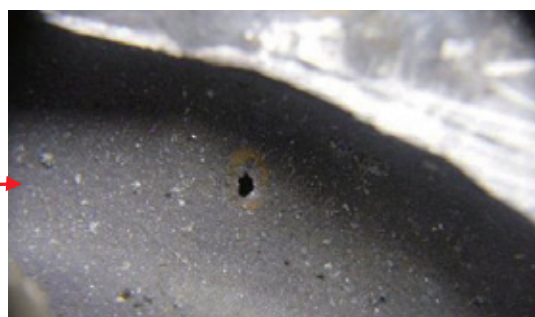
#### (2) Pitting in the body (through the hole reaching the drain hole and resulting in coolant leak)

Drain hole

Occurrence of erosion by cavitation

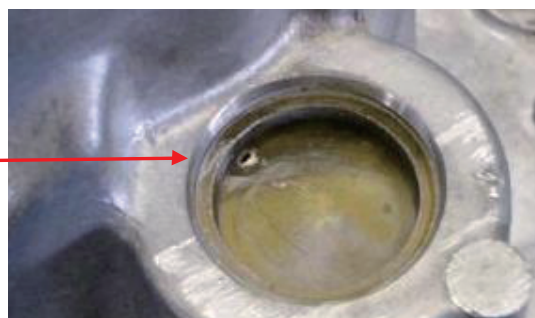
#### (3) Pitting in the plug

Occurrence of erosion by cavitation

Plug

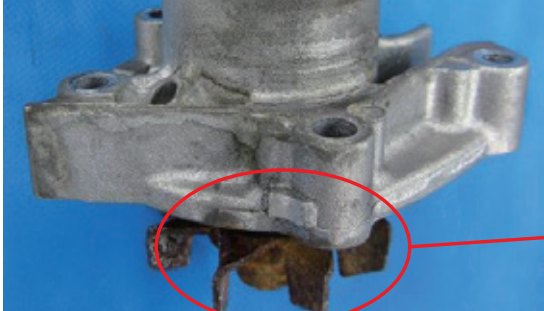
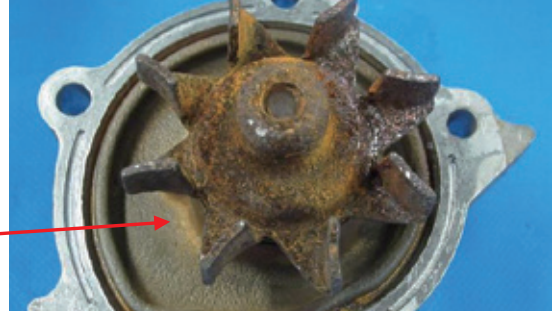
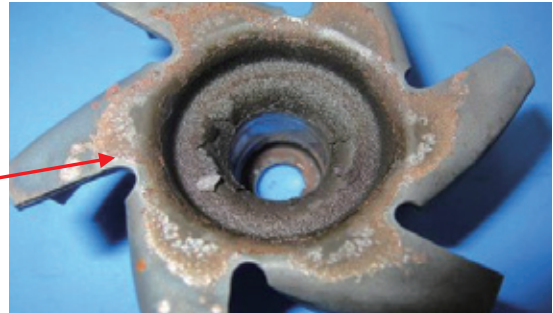
**(4) Rust occurrence with the impeller** Occurrence of corrosion and rust

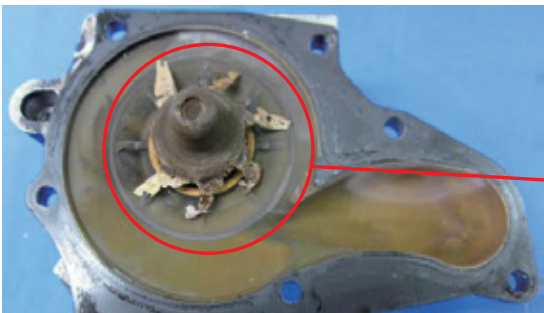
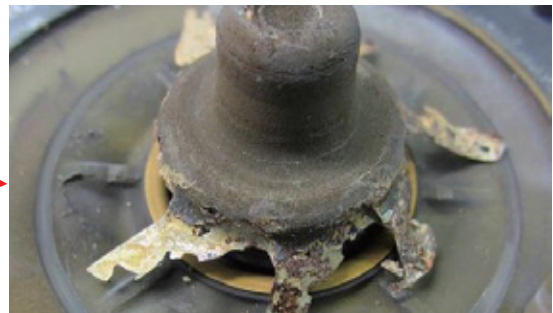
**(5) Impeller corrosion and loss** Occurrence of erosion by corrosion and cavitation

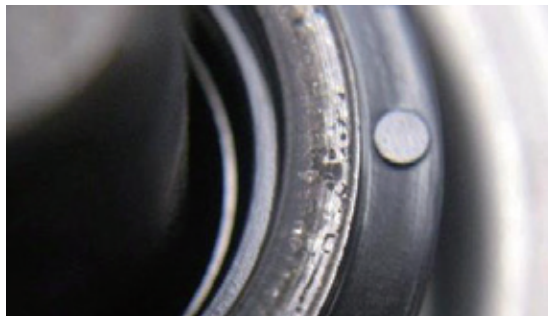
- (1) **Carbon transfer onto sliding surface** Components of the seal ring (fixed side) transferred to mating ring (rotating side)  
Travel distance: 0 km

Carbon transfer

Seal squeaking with mechanical seal is a phenomenon in which self-excited vibration caused by stick-slip between sliding surfaces (seal surface) becomes the source of noise. Stick-slip is caused by changes in sliding surface properties (e.g., carbon transfer, surface polishing, and uneven contact) occurring because of factors such as the starting of the engine in dry state (i.e., no coolant in the pump chamber), degraded coolant, and poor lubrication due to low concentration.

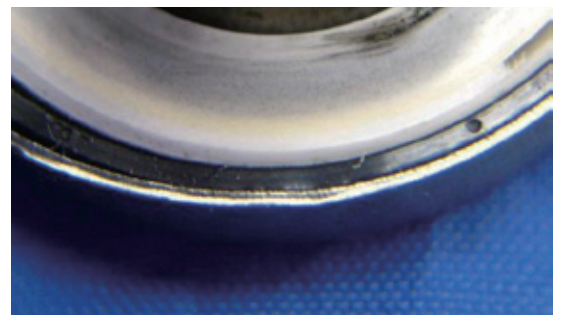
- (3) **Uneven contact of sliding surface** Increase in surface pressure occurred at a seal surface portion due to seal surface lubrication fault, etc.  
Travel distance: 0 km

Uneven contact

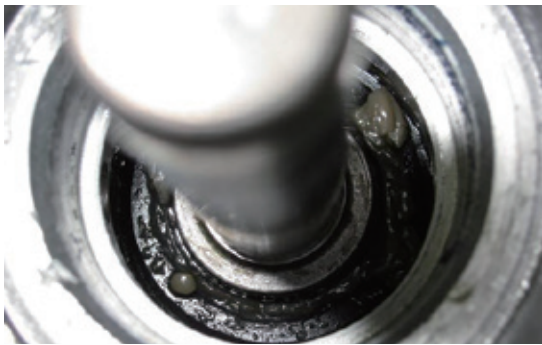
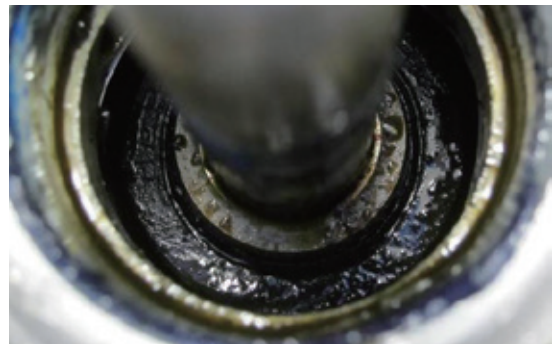
#### (1) Bearing damage (coolant intrusion into bearing)

- Coolant leak ⇒ Coolant intrusion into bearing ⇒ Degradation of bearing grease
- Excess belt tension
- Excessive vibration and other unfavorable responses due to fastening failure with mating part, deflection, or unbalance. As a result of excessive vibration, **\*fretting** wear occurs to the contact surface and fastening parts (characterized by occurrence of cocoa-colored rust).

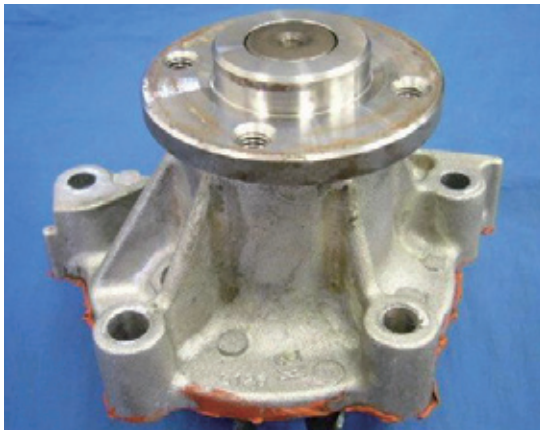
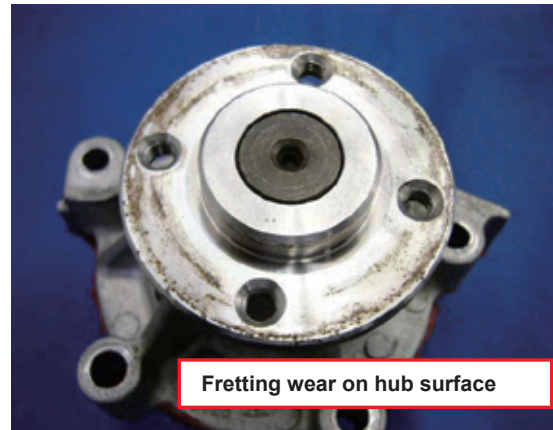
### (3) Bearing damage (burns to shaft and ball)

Travel distance: 5,000 km

Installed period: 6 months

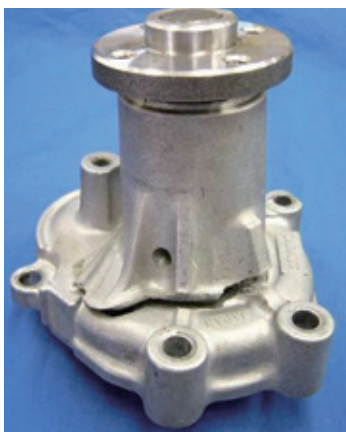
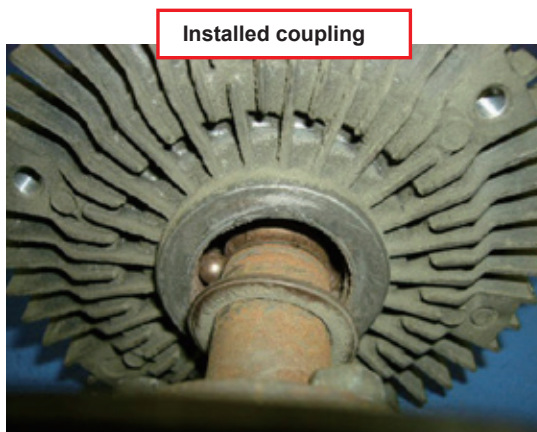
#### (1) Body damage

If the use of a defective part is continued, excessive vibration by whirling can damage the pump.

- If staggering or sticking is recognized with the rotation of coupling bearing, or if there is damage to the bearing seal, replacement is required.
- Even when there is no abnormality, we recommend replacing the coupling if the travel distance of 100,000 km is exceeded.
