WATER PUMP TECHNICAL SUPPORT BOOK

What is a water pump?

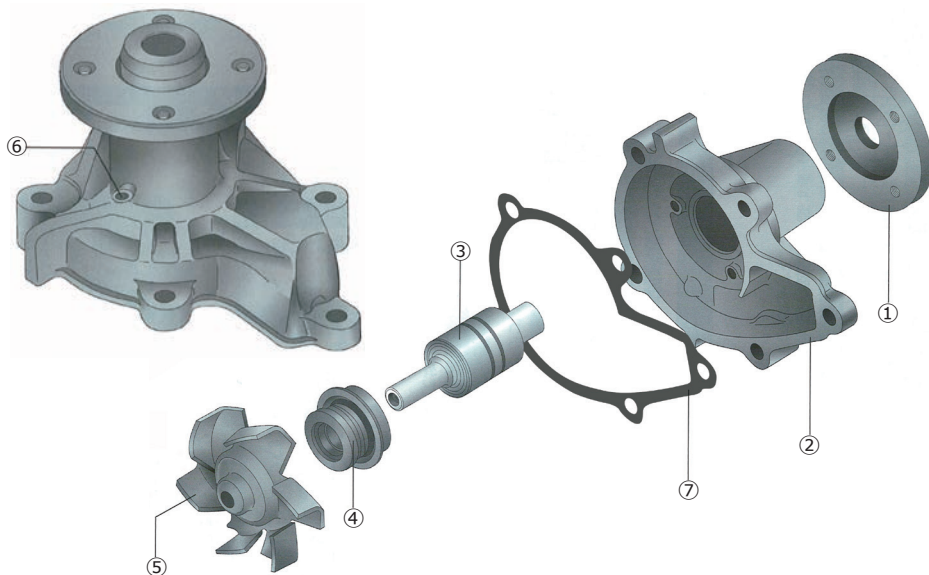
Structure

- ① Hub
- ② Body
- ③ Bearing
- ④ Mechanical seal
- ⑤ Impeller
- ⑥ Drain hole
- ⑦ Gasket

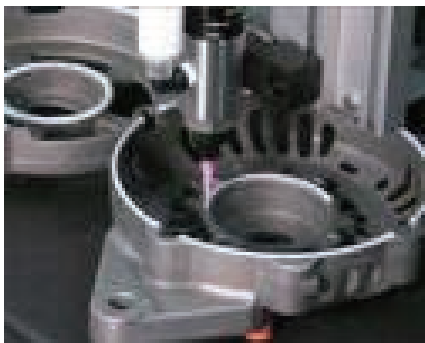
■ Liquid gasket applicator

In the production line, stringent control on the application amount is implemented by the use of components including an FIPG applicator.

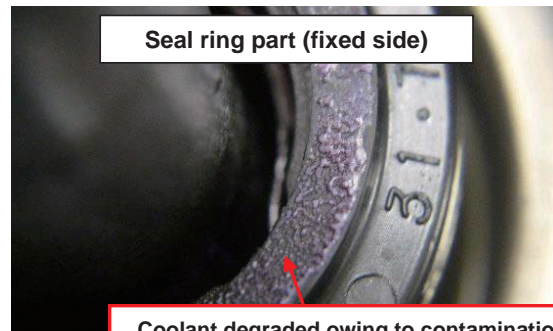
(1) Coolant contamination

- If cleaning is not sufficient or the coolant is not replaced in its entirety, contaminants such as dust, sludge, and sand in the coolant path can be caught onto the mechanical seal sliding surface (seal surface), and coolant may leak from the drain hole resulting from a loss of sealing performance.

Installed period: 3 days

Mating ring part (rotating side)

Seal ring part (fixed side)

Coolant degraded owing to contamination

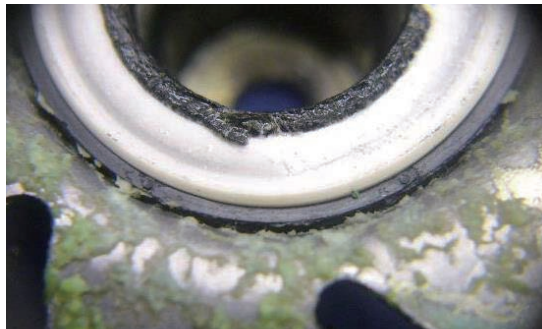
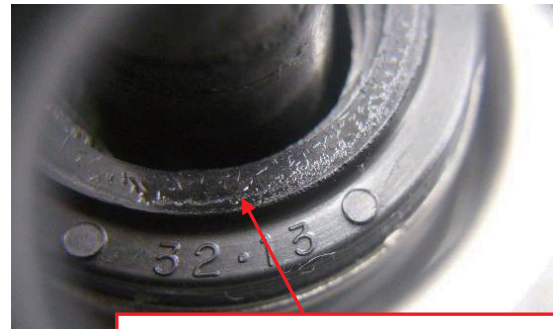
Travel distance: 5,000 km

Coolant degraded owing to contamination

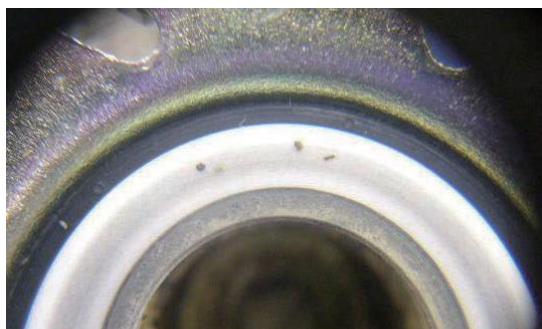
(2) Contaminant biting in mechanical seal

Installed period: 3 months

Contaminant biting

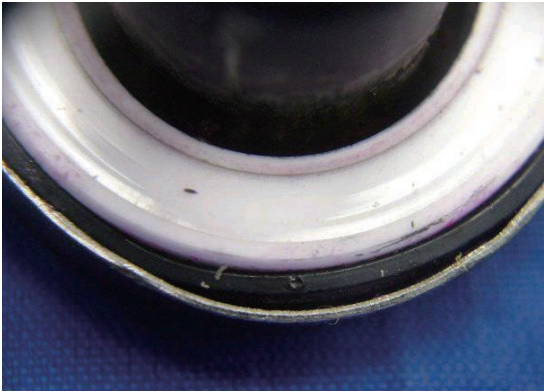
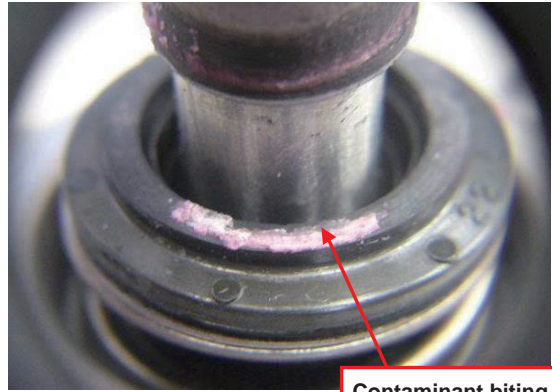
(3) Contaminant biting in mechanical seal

Travel distance: 42 km

Contaminant biting

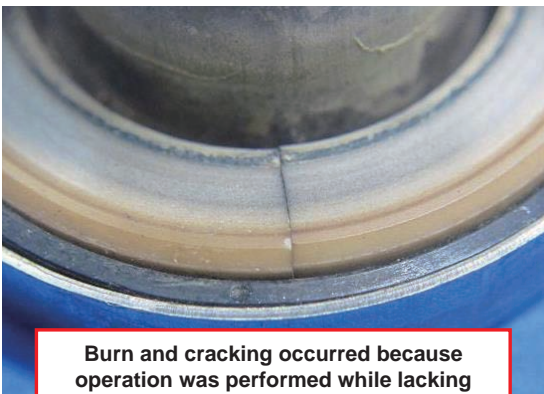
(4) Burn and cracking of mating ring

Travel distance: 8,189 km

Burn and cracking occurred because operation was performed while lacking coolant after coolant level became low.

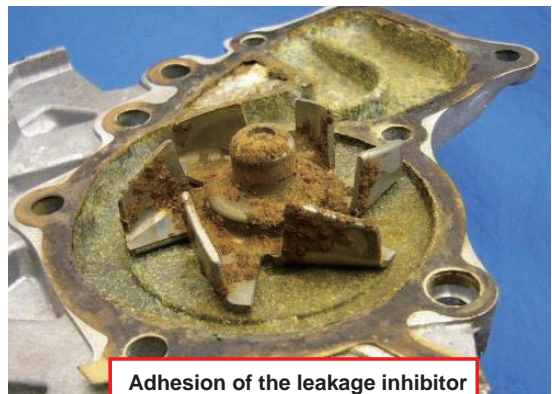
(5) Other (charging of leakage inhibitor)

Travel distance: 10,000 km

Adhesion of the leakage inhibitor to the pump chamber

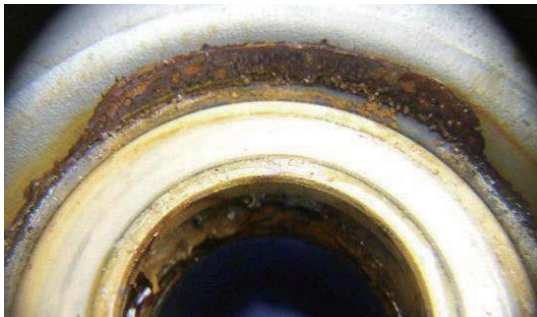
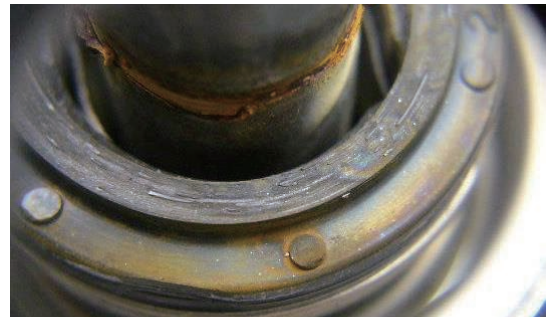
(1) Rust biting in mechanical seal

- Metal corrosion can generate biting contaminants, such as rust, in the mechanical seal sliding surface (seal surface), ultimately causing coolant leak from the drain hole.
- Propagation of metal corrosion and *cavitation can lead to coolant leak resulting from pitting as well as to overheating resulting from a loss of impeller. *Cavitation: See page 22

Travel distance: 42 km

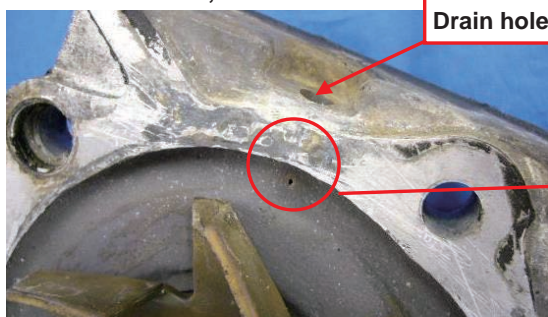
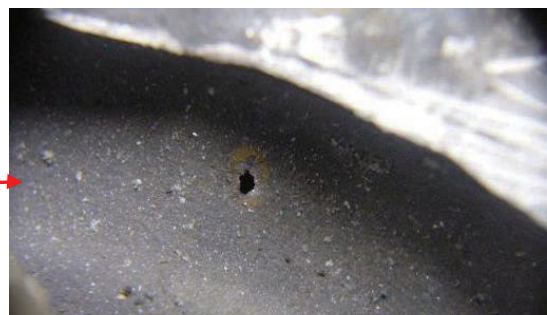
(2) Pitting in the body (through the hole reaching the drain hole and resulting in coolant leak)

Travel distance: 9,000 km

Drain hole

Occurrence of erosion by cavitation

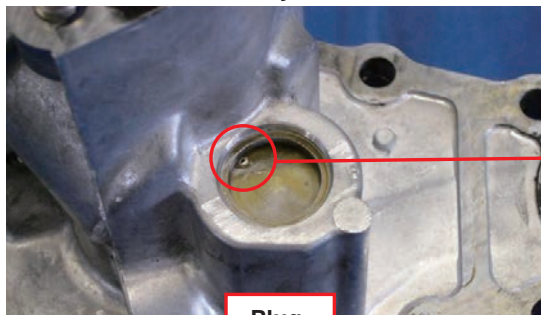
(3) Pitting in the plug

Occurrence of erosion by cavitation

Plug

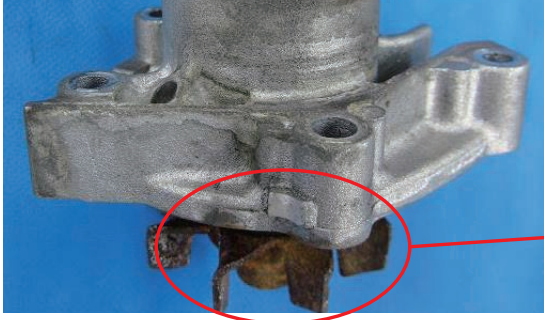
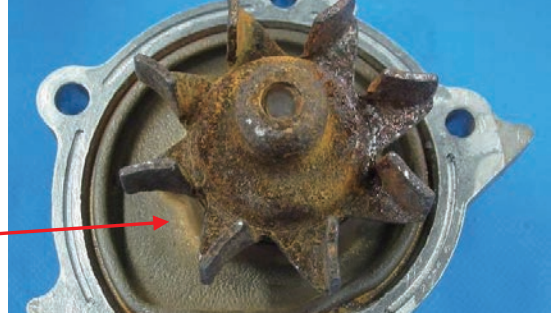
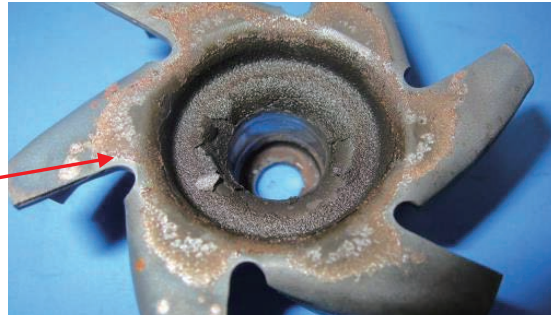
(4) Rust occurrence with the impeller Occurrence of corrosion and rust

Travel distance: 7,646 km

Installed period: 12 months

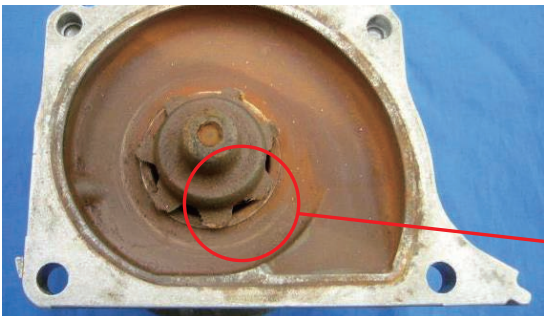
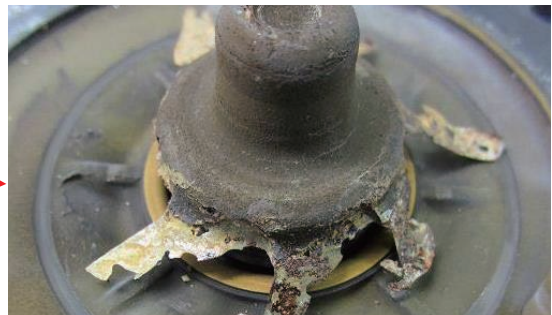
(5) Impeller corrosion and loss Occurrence of erosion by corrosion and cavitation

Installed period: 6 months

Installed period: 12 months

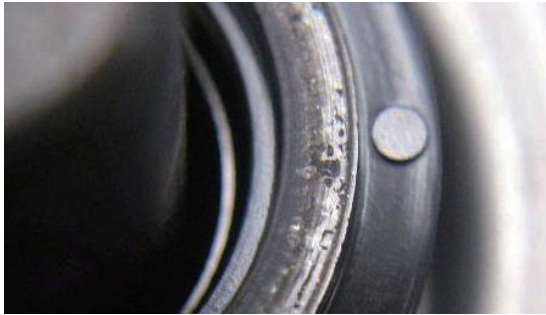
- (1) **Carbon transfer onto sliding surface** Components of the seal ring (fixed side) transferred to mating ring (rotating side)

Travel distance: 0 km

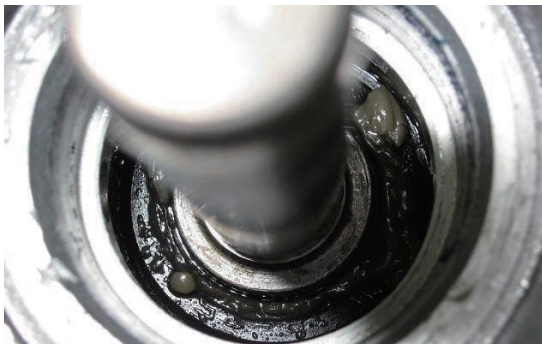
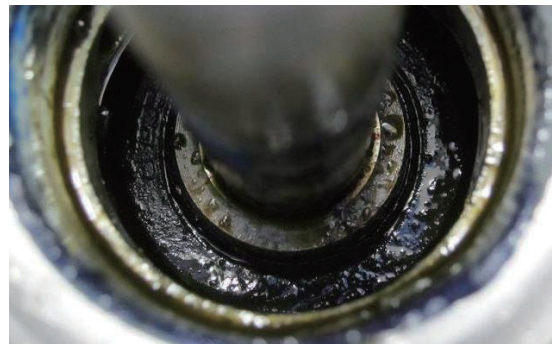
(1) Bearing damage (coolant intrusion into bearing)

- Coolant leak ⇒ Coolant intrusion into bearing ⇒ Degradation of bearing grease
- Excess belt tension
- Excessive vibration and other unfavorable responses due to fastening failure with mating part, deflection, or unbalance. As a result of excessive vibration, ***fretting** wear occurs to the contact surface and fastening parts (characterized by occurrence of cocoa-colored rust).

Installed period: 8 months

Installed period: 12 months

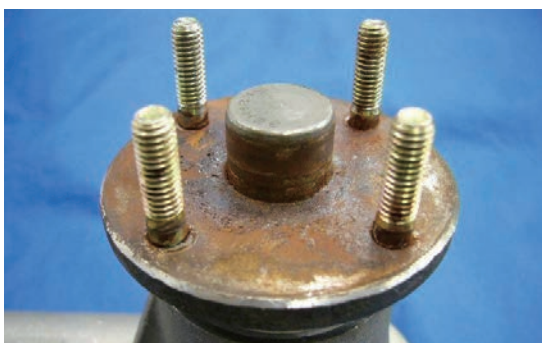
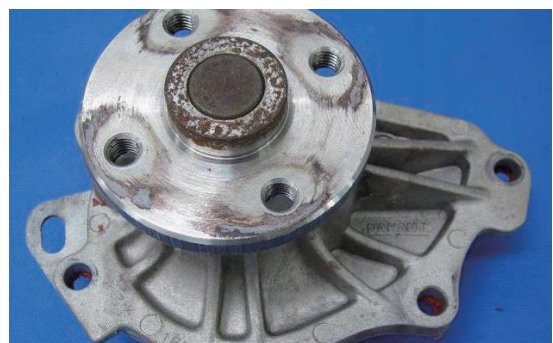
(2) Bearing damage (fretting wear on hub surface and hub axle)

Installed period: 2 months

Travel distance: 5,149 km

Travel distance: 9,750 km

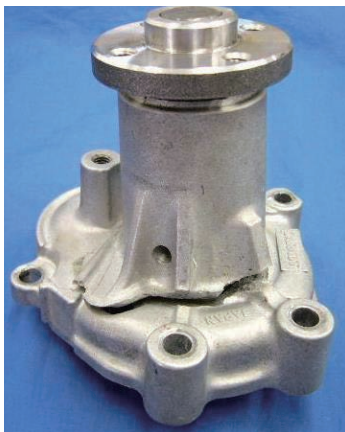
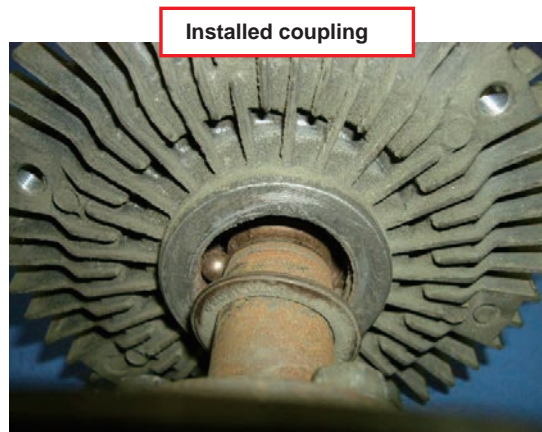
(1) Body damage

If the use of a defective part is continued, excessive vibration by whirling can damage the pump.

Travel distance: 98 km

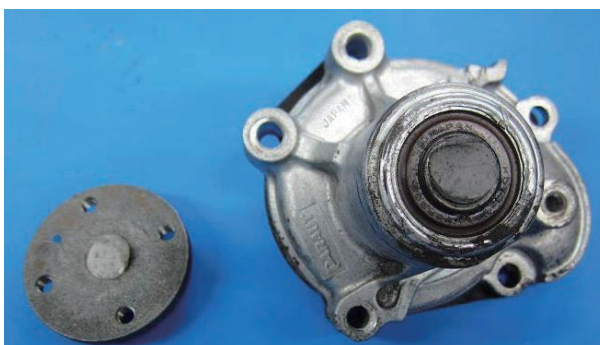
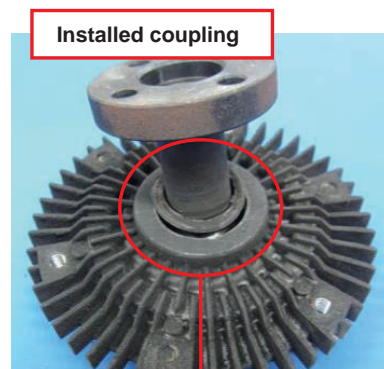
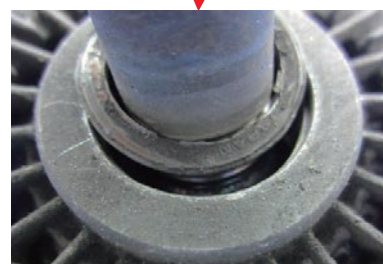
(2) Bearing shaft breakage

Installed period: 9 months
